Manhole Inspection Summary

Manhole # S37E__010MH

Location Address: **rear 500 e lexington st**

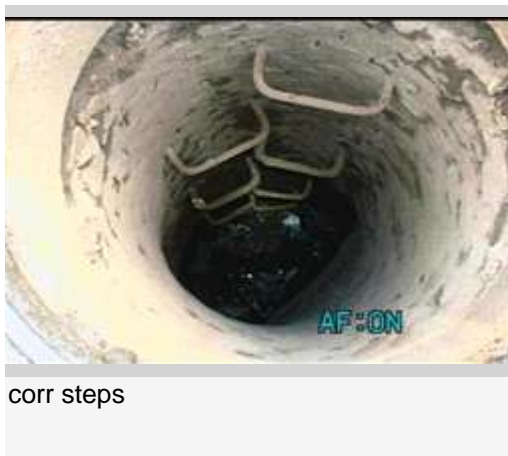
Defect 2

Count: **8** Missing: **0** ☒ **Corroded**

corr steps

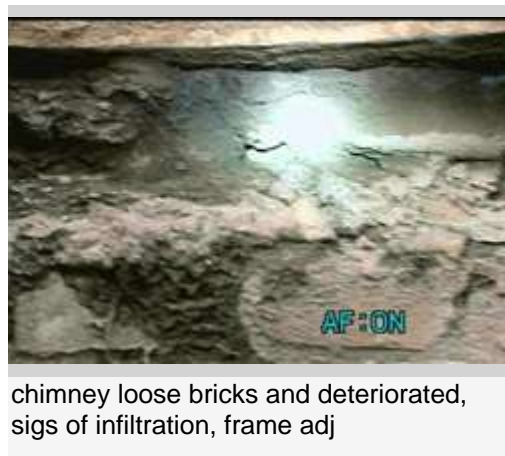
Defect 1

Condition: ☐ Sound ☐ Cracked ☐ Root Intrusion ☒ **Loose Brick** ☒ **Deteriorated**

Infiltration: ☐ None ☒ **Joint** ☐ Cracks ☐ Mortar ☐ Roots ☐ Wall

chimney loose bricks and deteriorated,
sigs of infiltration, frame adj

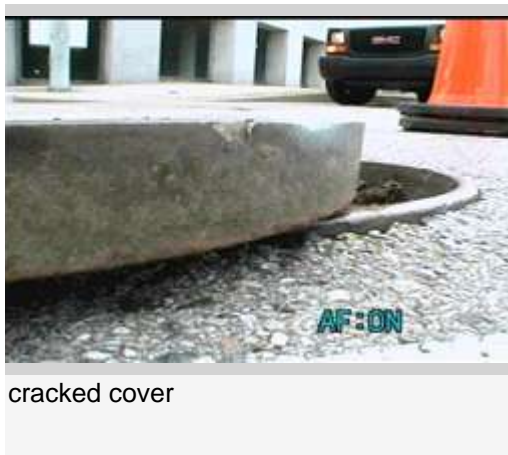
Defect 6

Condition: **Cracked**

cracked cover

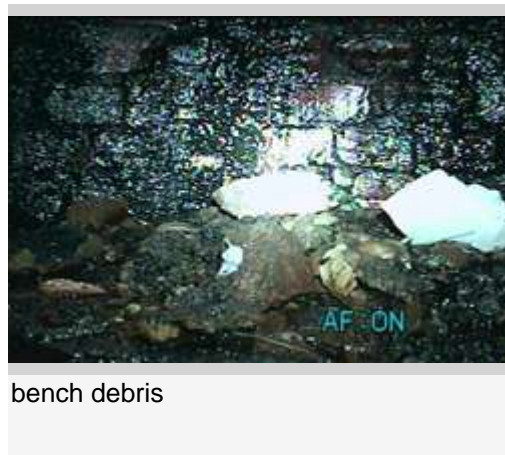
Defect 5

Condition: ☐ Sound ☐ Cracked ☐ Root Intrusion ☐ Deteriorated ☐ Leaks ☒ **Debris**

bench debris

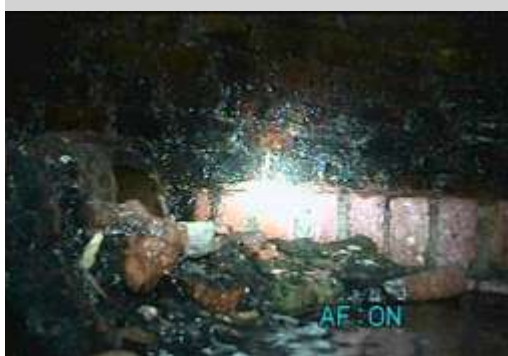
Defect 4

Condition: ☐ Sound ☐ Cracked ☐ Root Intrusion ☐ Deteriorated ☐ Leaks ☒ **Debris**

channel debris

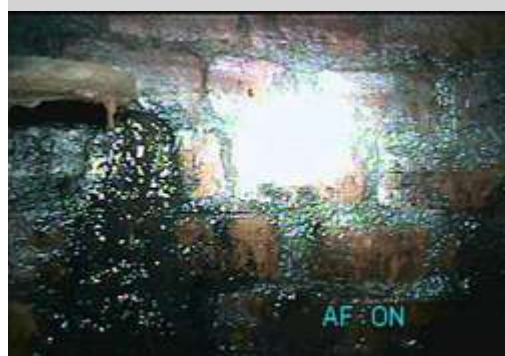
Defect 3

Condition: ☐ Sound ☐ Cracked ☐ Root Intrusion ☐ Loose Brick ☒ **Deteriorated**

Infiltration: ☐ None ☒ **Joint** ☐ Cracks ☐ Mortar ☐ Roots ☒ **Wall**

barrel infiltration
